GIANT FOREST  
**SEQUOIA**

**A Historical and Architectural Study of  
Three Rustic Structures at Giant Forest in Sequoia National Park  
The Market, District Ranger's Residence, and Comfort Station**

**HISTORIC STRUCTURES REPORT  
SEQUOIA NATIONAL PARK**

Approved  
December 7, 1988

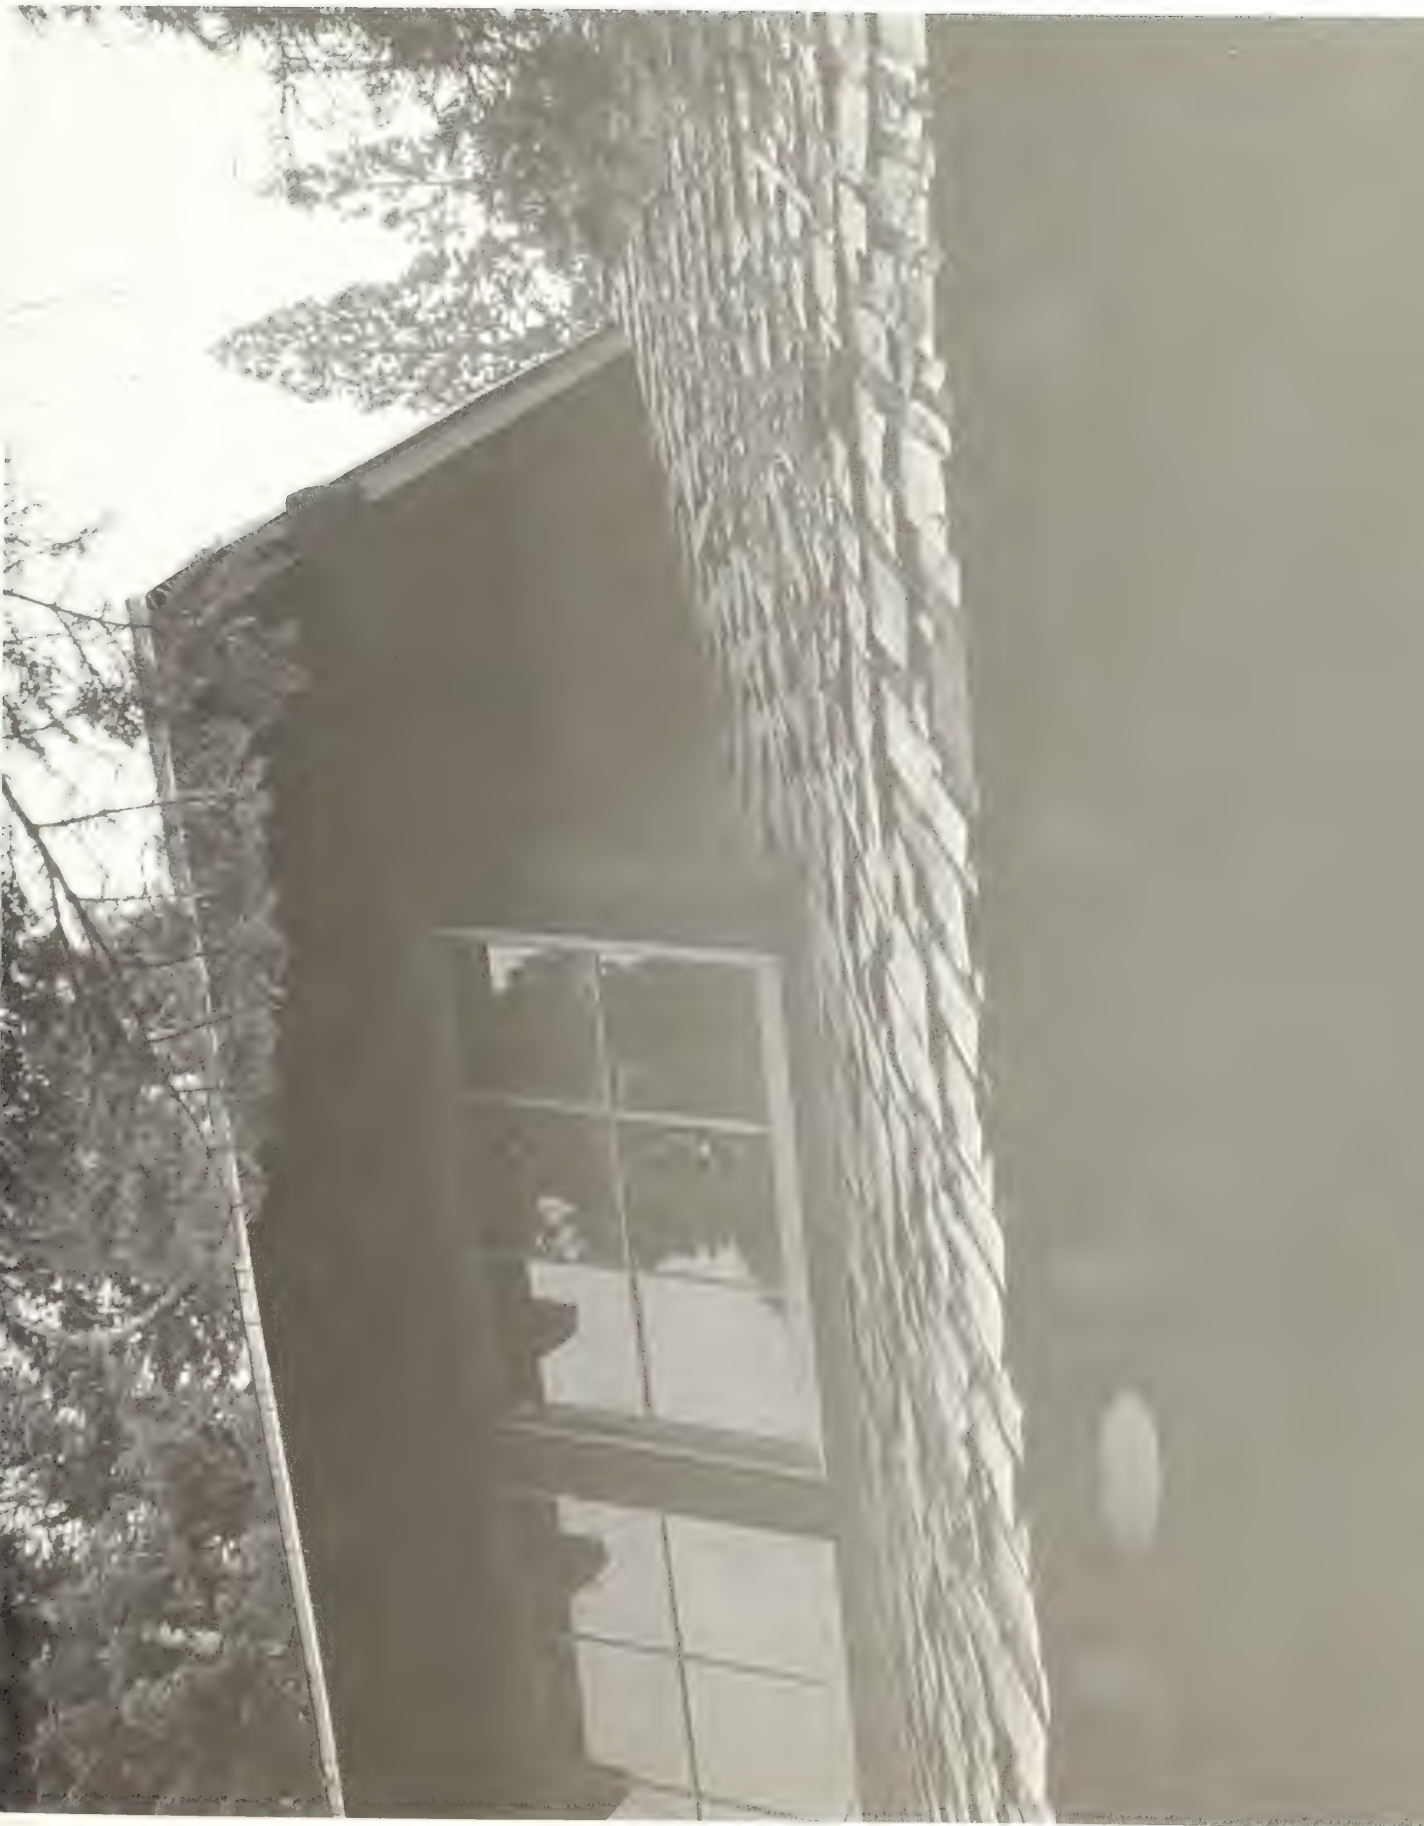
Figure 29. Market Dormer and Roof Detail (1973). The shake roof, some 44 years old at this point, is severely deteriorated. Notice edge flashing on dormer roof and roll roofing (it had no shakes), and outdoor lamp under roof eave. (Photo by Bill Jones, SEQU archive collection)

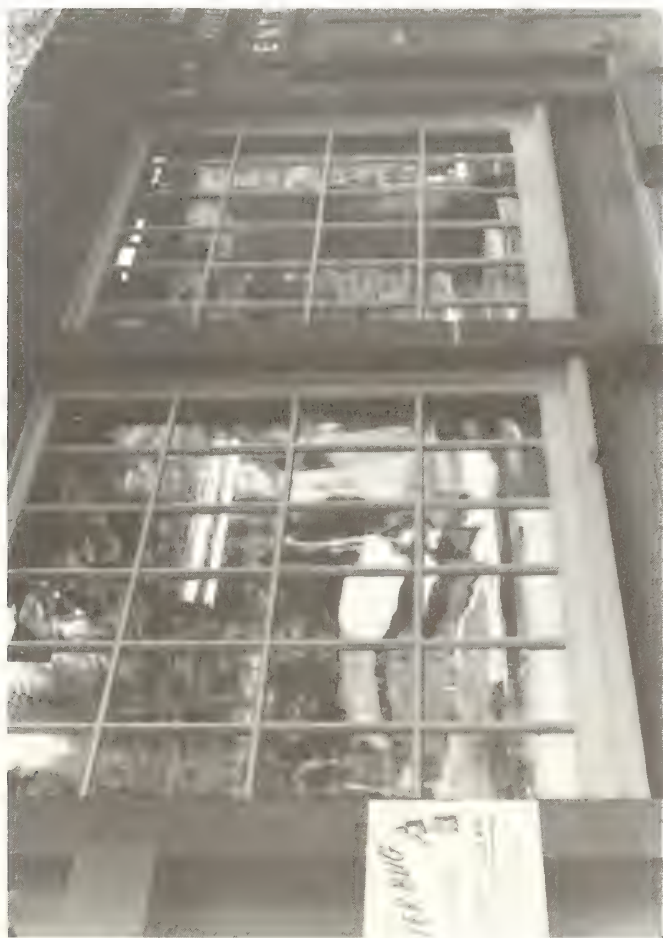
Figure 81 (left). Market Door (10/86). Most of the market doors were bi-fold, center hinged. This door--to room 100--is the only unmodified bi-fold door remaining. It is inoperative because asphalt has been placed at its sill to control water run-off. The negative effect of the asphalt is that it traps moisture against the door causing it to rot. This asphalt walk also buries a crawl space vent window to the left of the door (not visible). The asphalt should be removed and the site grade lowered. Door repairs may involve replacement of excessively rotted members, filling holes and refinishing. Door hardware should be cleaned, repaired, duplicate replacement parts installed and historically finished.

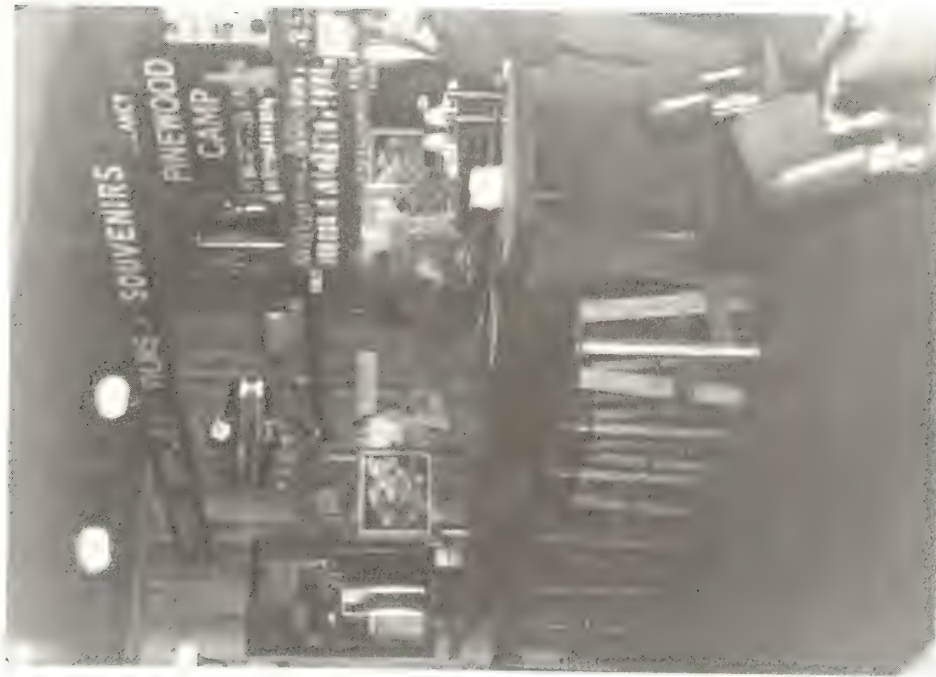
Figure 91. Comfort Station, View from Southeast (ca. 1983). The south facade is cluttered with electrical wiring and equipment which covers up one window. These accretions should be removed as part of the utility rehabilitation and distribution lines should be placed underground. The smooth asphalt walkway becomes slippery under these weather conditions. The walk could be made smaller, a new textured surface installed and additional handrailing considered. Note site grade in contact with wooden sill at this corner. Earth removal and installation of a more functional drainage swale is recommended. (HABS #CA 2148 C-3)

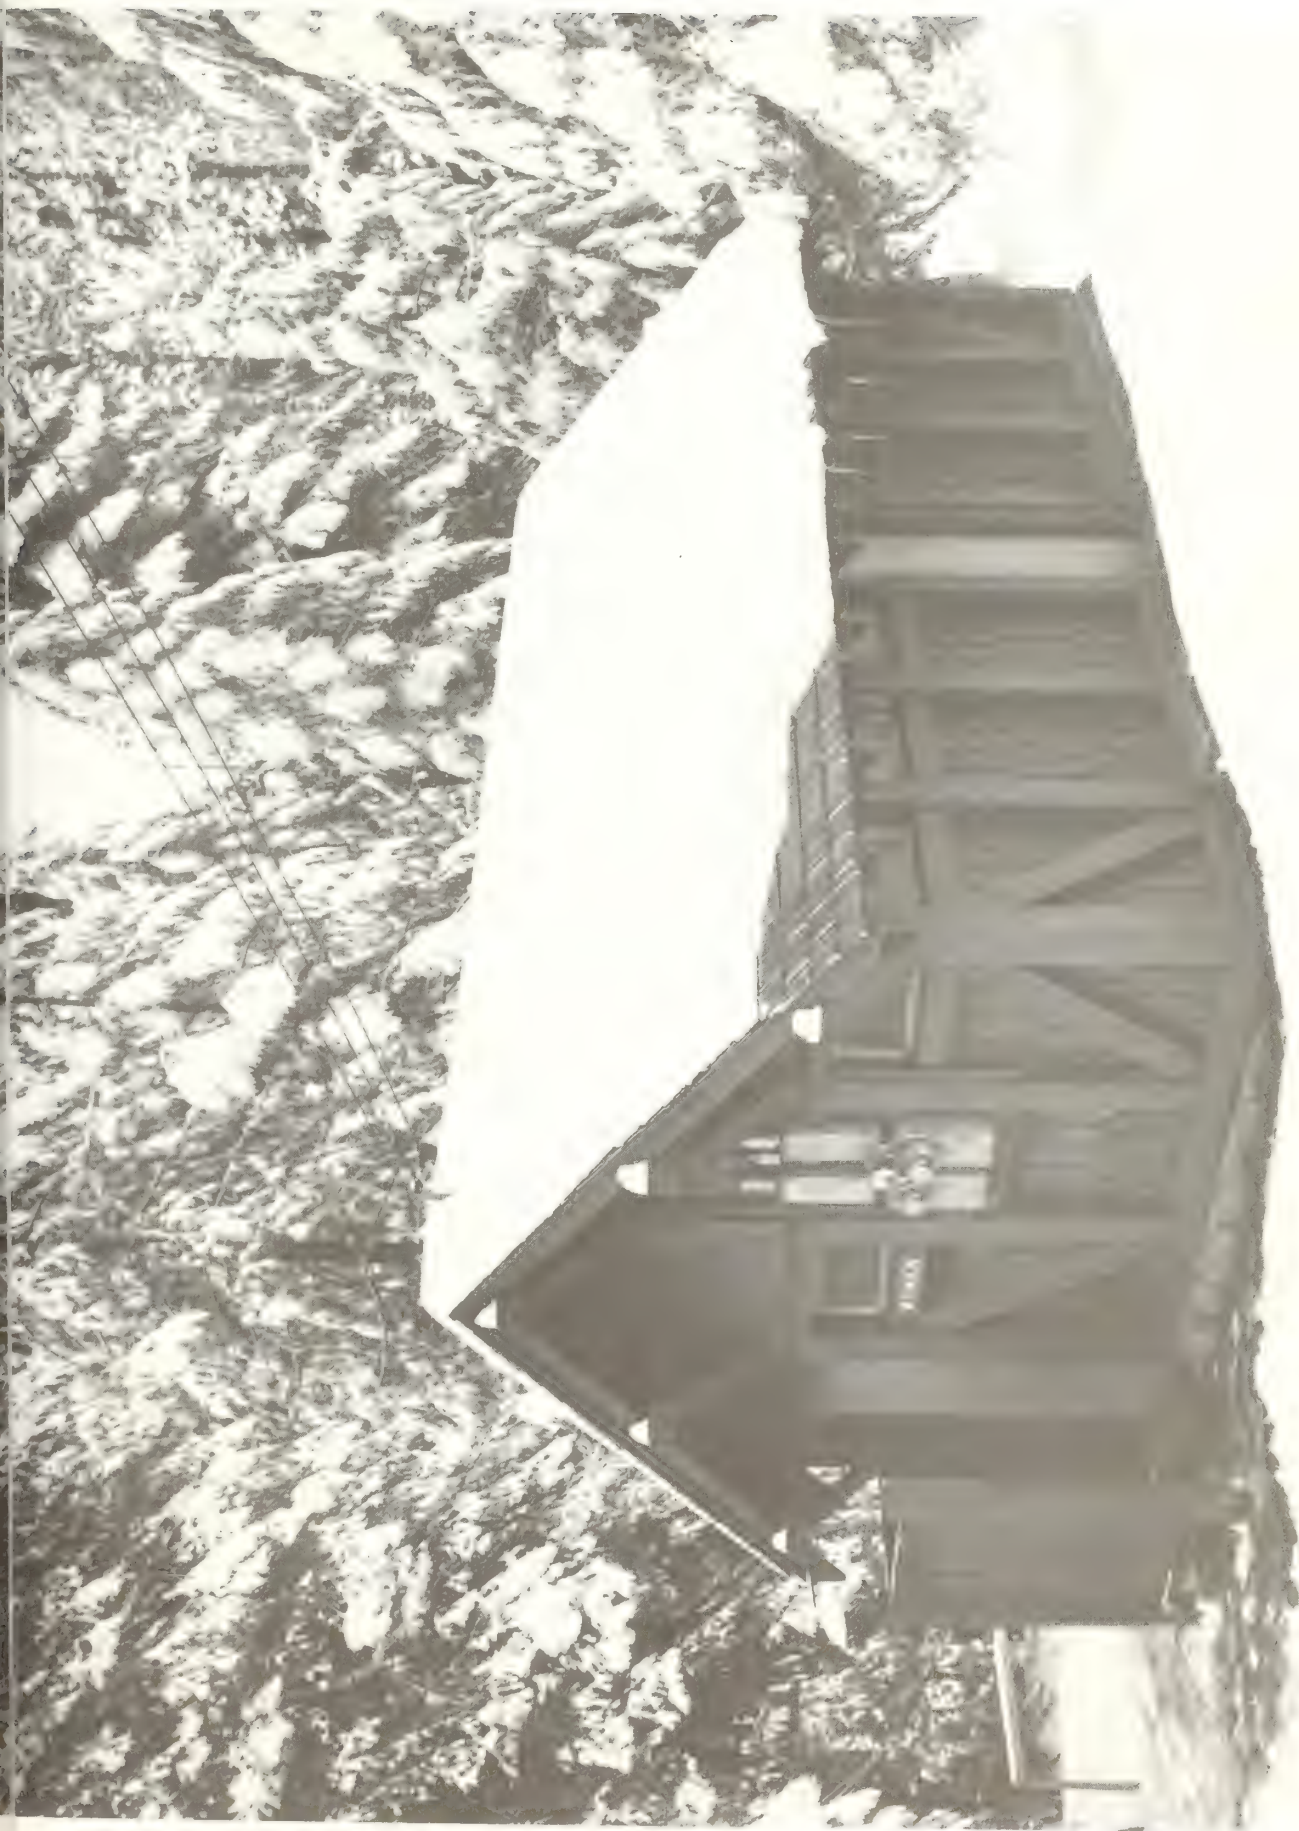
Figure 92. Comfort Station Accessibility (10/86). The asphalt walks in Giant Forest Village are gently sloped. At this location, however, the overall rise from parking level to comfort station floor level is more than 10 feet over a distance of less than 80 feet (to the men's side). To achieve handicapped accessibility standards, nearly twice this length would be required--a switchback ramping system would be necessary. The handrail visible here is bent, intrusive and marginally effective for this 10-foot wide walk. The water fountain seen in the left photograph should probably stay here although the Area Study should confirm such decisions.

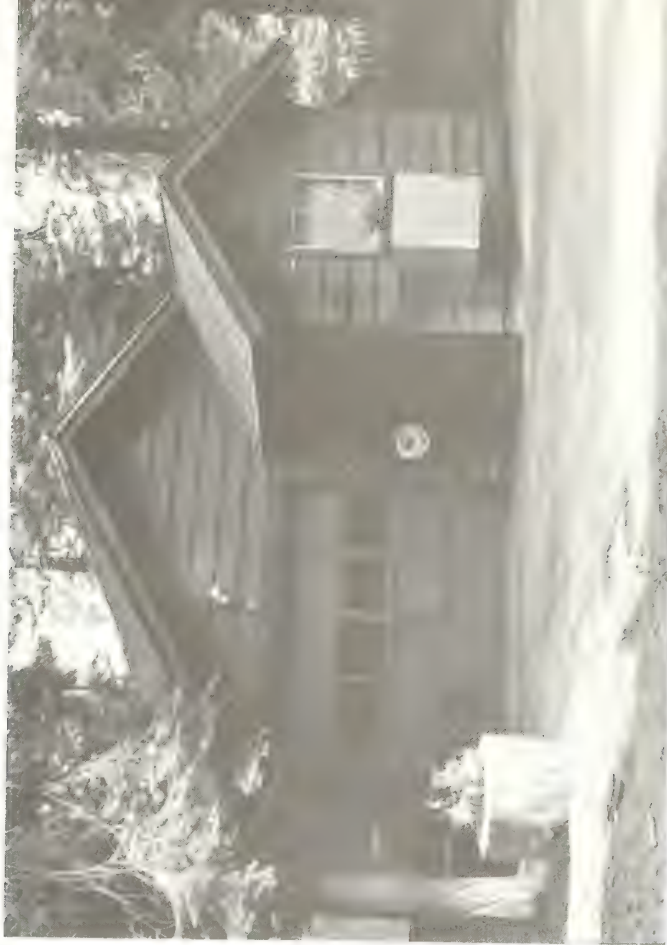
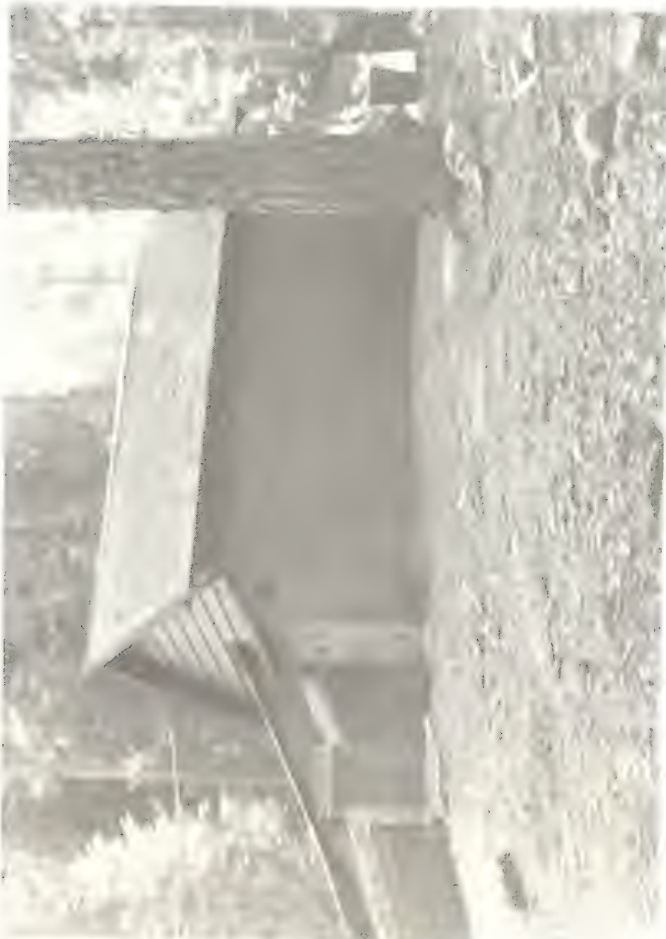
Figure 98. Ranger Residence Garage (5/86 and 10/86). At left, view from west; at right view of entry from south. Repainting, reroofing and installation of GFCI's are recommended at the garage.

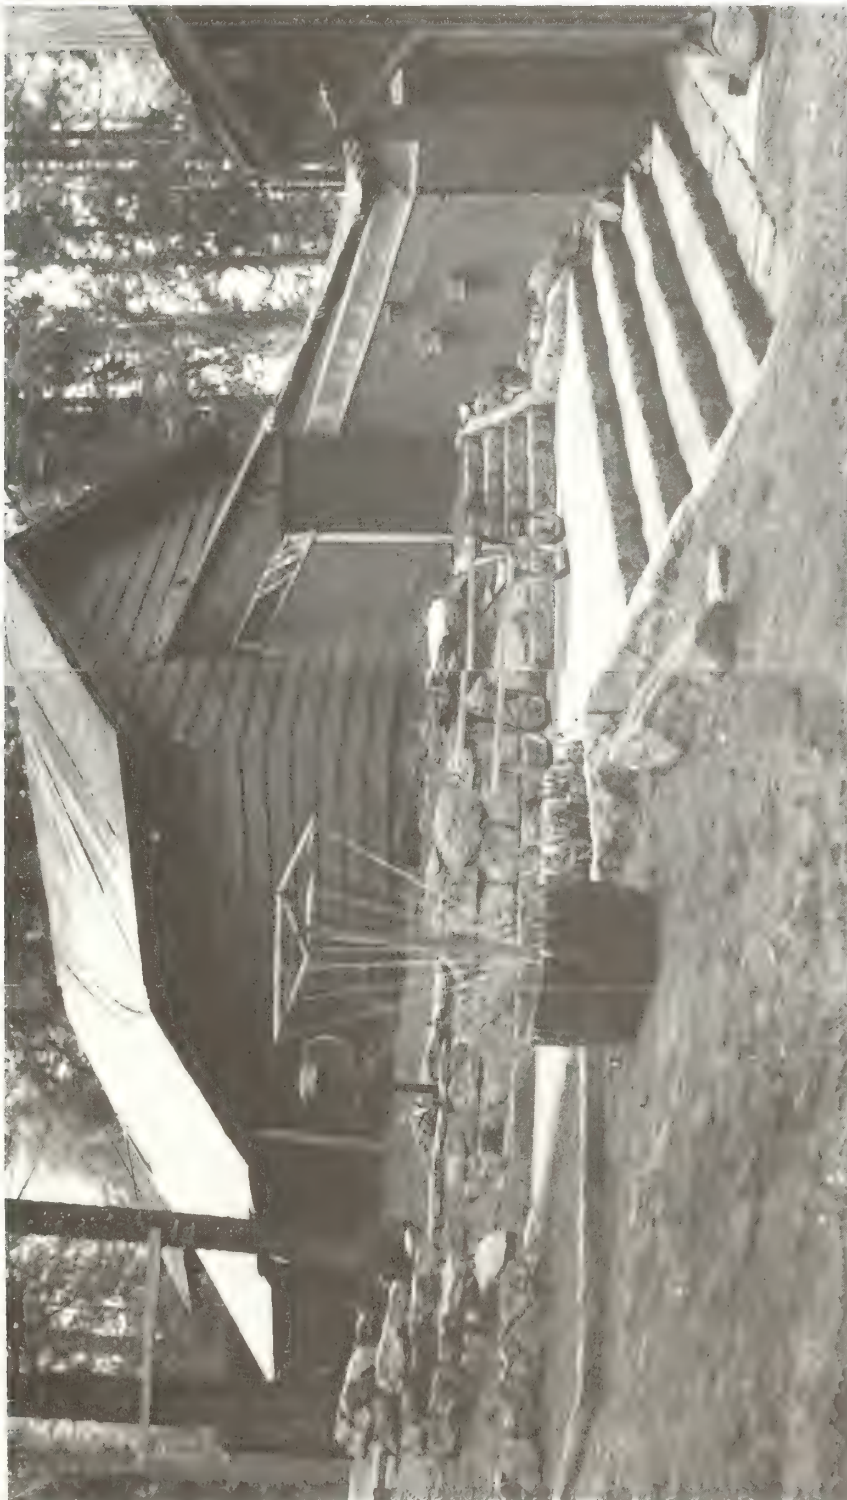
Figure 99. Ranger Residence/Garage, View from East (10/86). The date of the stone and concrete patio development is not known but it is of compatible material. The site drainage, however, is deficient as a result of both water from the patio and the gutter/downspout being concentrated at the southeast corner of the residence at right. This should be corrected. It's interesting and out of character that the siding and windows of the snow tunnel follow the slope of the land rather than being placed horizontally as is the siding of both the residence and garage.

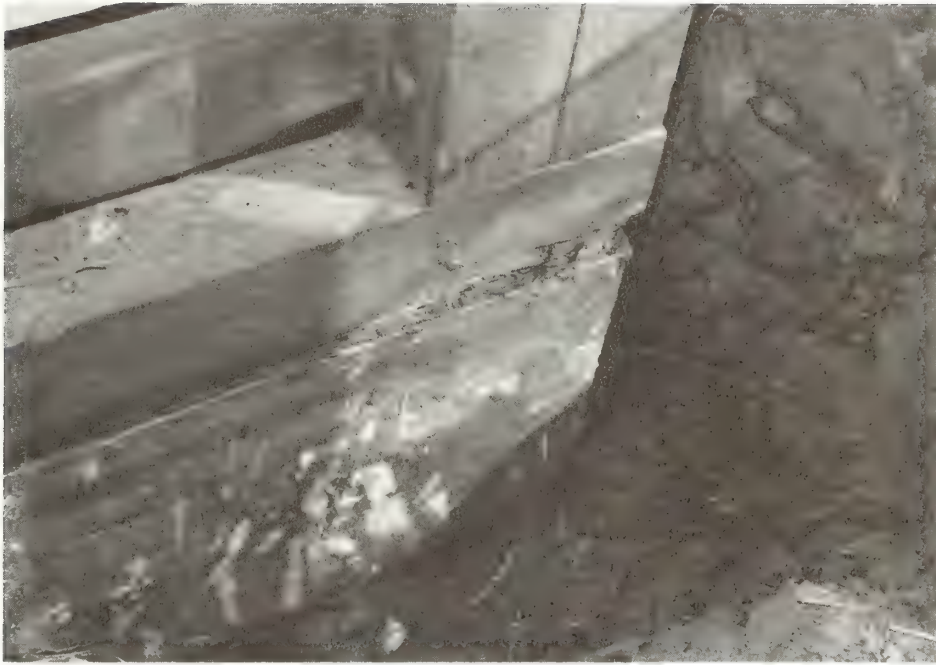
Figures A-8 and A-9. Market at southeast corner, test pit A (10/86). The upper view shows the extent of the exploratory excavation. The hole goes down 28" below top of concrete (below sill beam) and extends from the southeast corner to the chimney. At right, the sill beam is rotted away as is clearer in the lower photograph. The plywood patch replaces several pieces of shiplap siding which rotted away and have been removed. The lower photograph also shows that the bottom of the corner puncheon has begun to be attacked by rot.

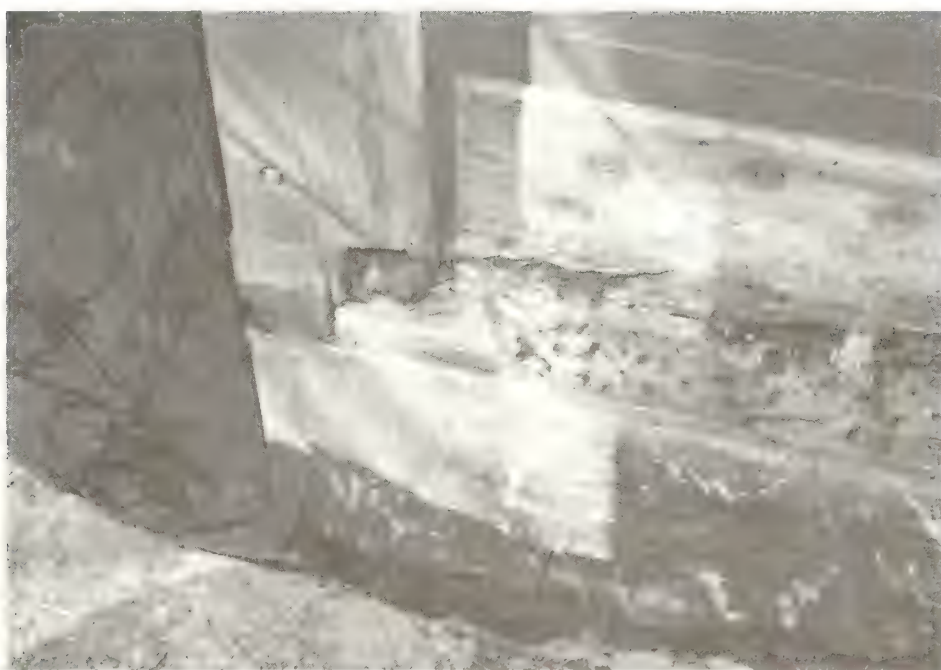
Figure A-10. Market, test pits B and C (10/86). The upper view shows the extent of excavation at the juncture between the east wall of the market, the 1930 chimney, at left, and the 1938 addition retaining wall, at right. At a depth of 5 feet was found the concrete footing, detail at bottom left. The photograph at bottom right shows test pit C at the southeast corner of the 1938 addition (with B at the upper right corner in the far ground). The addition wall is battered slightly to function as a retaining wall. It also was coated with a moisture barrier, but this is no longer effective. the 1½-inch gas line, visible in both test pits, comes from the main manifold on the west side of the market, up through the market attic and exits at this location where it goes to another building--it does not serve the market.

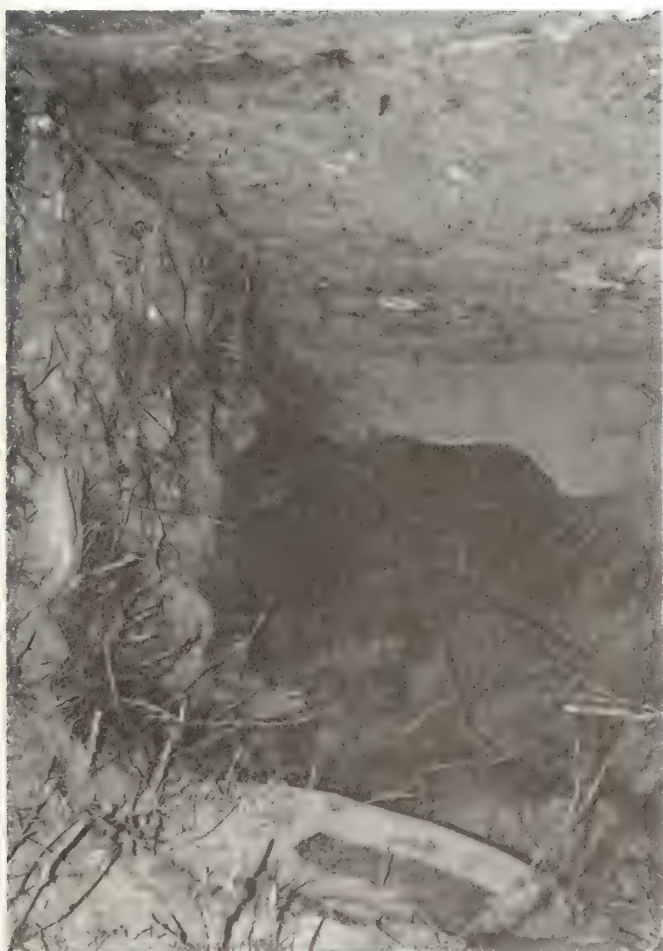
Figure A-11. Market, Test Pits D and E (10/86). These views show the extent of excavations along the east (rear) wall of the 1938 addition. Both of these holes are about 5-feet deep, both revealed the lip of the wall footing, confirmed the batter of the wall and its condition. The bitumin waterproof coating is consistently ineffective. Also, both pits included the 6-to-8-inch thick gravel drainage lense which helps establish the original grade and the depth of the proposed drainage excavation along the rear of the building.

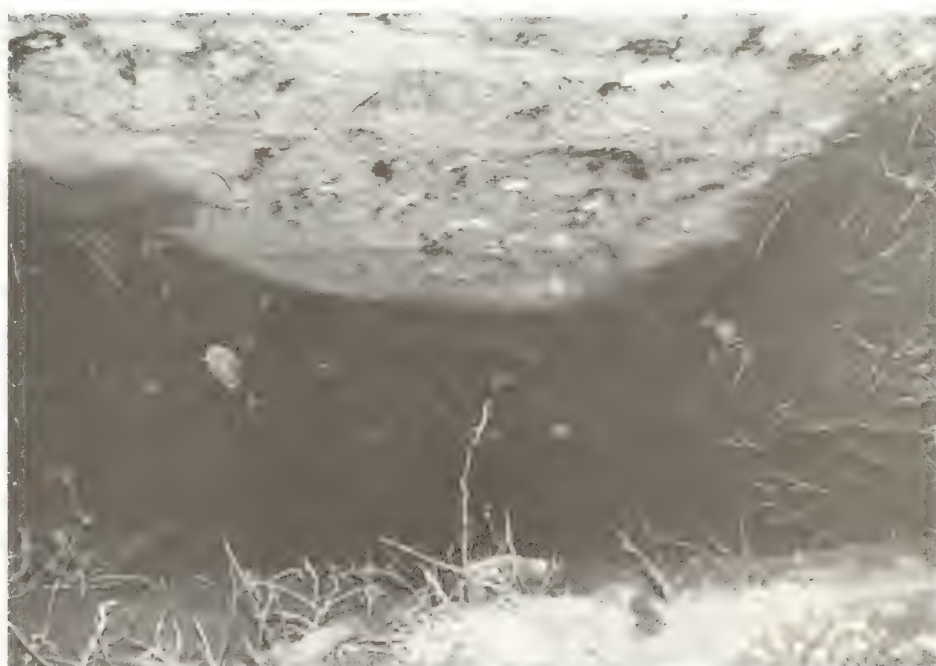
Figure A-12. Market Interior Fabric Investigation at Southeast, Room 100 (10/86). Plywood patches, part of a repair job of the 1970s or early 1980s, were removed from both floor and wall at this corner adjacent to the fireplace. The repair was done to replace rotted material, but did not address the cause of the rot--excessive moisture. Besides rotted joists, subfloor, beams and wall paneling, also revealed by this exploration was the shallowness of the crawl space and the fact that several crawl space ventilation windows are entirely blocked by exterior soil build-up.

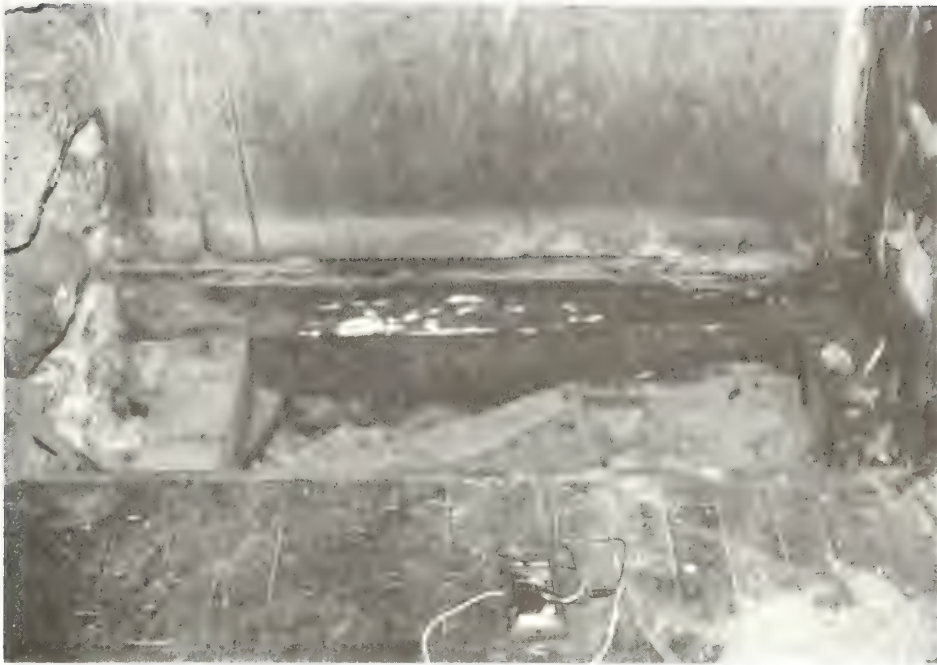
Figures A-13 and A-14. Market Crawl Space (5/86 and 10/86). The upper view shows the crawlspace as seen below the north end of the market where there is about 30 inches between the earth floor and the wooden subflooring. The lower view shows one of the 5 x 7 (6½" x 4-3/4" typically) floor beams vertically in contact with the earth. The end joist in the lower view is severely rotted and instrument readings indicated nearly 30% moisture content. Some of the crawl space earth should be excavated at the south end, several structural members must be replaced and the crawl space ventilation system needs to be improved.

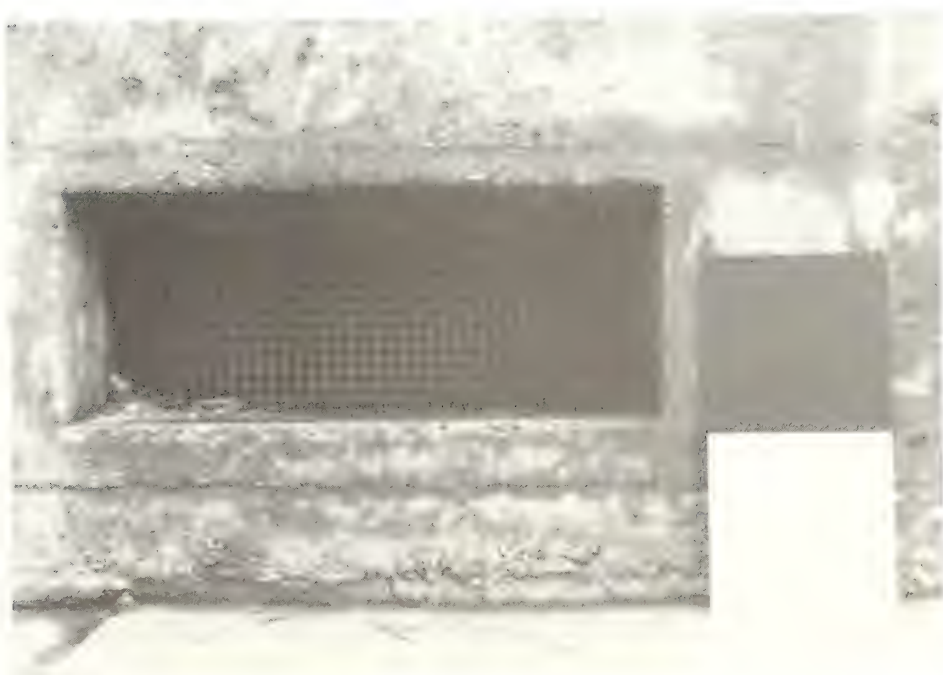
Figure A-17. Market Interior Fabric Investigation, West Side of Room 100 (10/86). A 27 x 19 inch section of flooring, which had been previously removed as part of a repair effort in the late 1970s or early 1980s, was taken up to reveal the nature of the "repair" and determine the extent of suspected deficiencies. Part of a joist and some subflooring had been replaced in the repair effort. Additional joists and subfloor are in need of similar treatment because of their advanced state of rot. The 1 x 4 base and a single wanescot panel were removed to reveal the cause of the deterioration. As in the investigation at the southeast corner, excessive moisture is the culprit--the crawl space is shallow, the vent window at this location is buried by the asphalt sidewalk outside, and the asphalt is used as a moisture barrier but traps moisture against the adjacent door threshold. See also next figure.
